NASA TECHNICAL
MEMORANDUM

NASA TM X-64819

MSFC SKYLAB INSTRUMENTATION AND COMMUNICATION
SYSTEM MISSION EVALUATION

Skylab Program Office

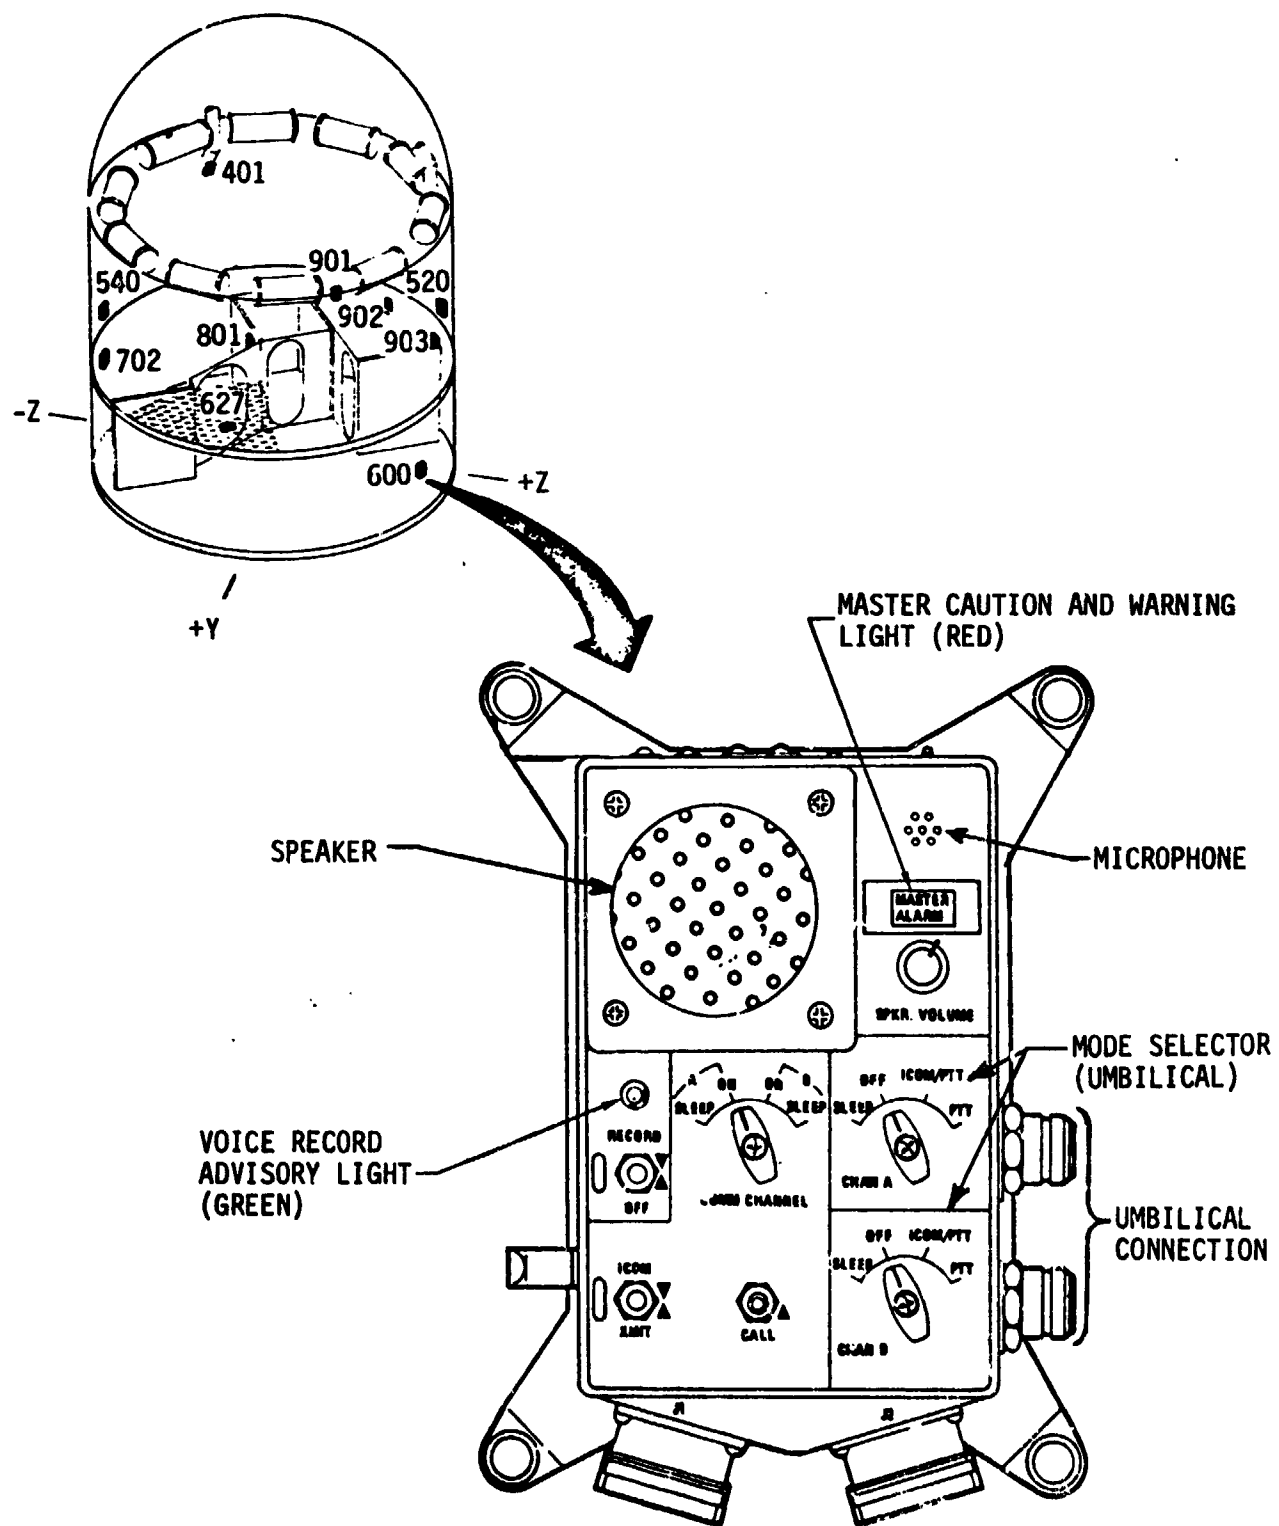
FIGURE 6-9 SIA PANEL AND LOCATIONS IN OWS

Audio feedback occurred primarily in the OWS between the SIAs at the wardroom (702), anti-solar scientific airlock, (540), and the one above the ergometer (627). See Figure 6-9. The three units located in the sleep compartments and in the waste management compartment did not cause any operational feedback problem primarily because of low usage, low speaker volume setting, and the relative isolation afforded by the walls in the waste management compartment.

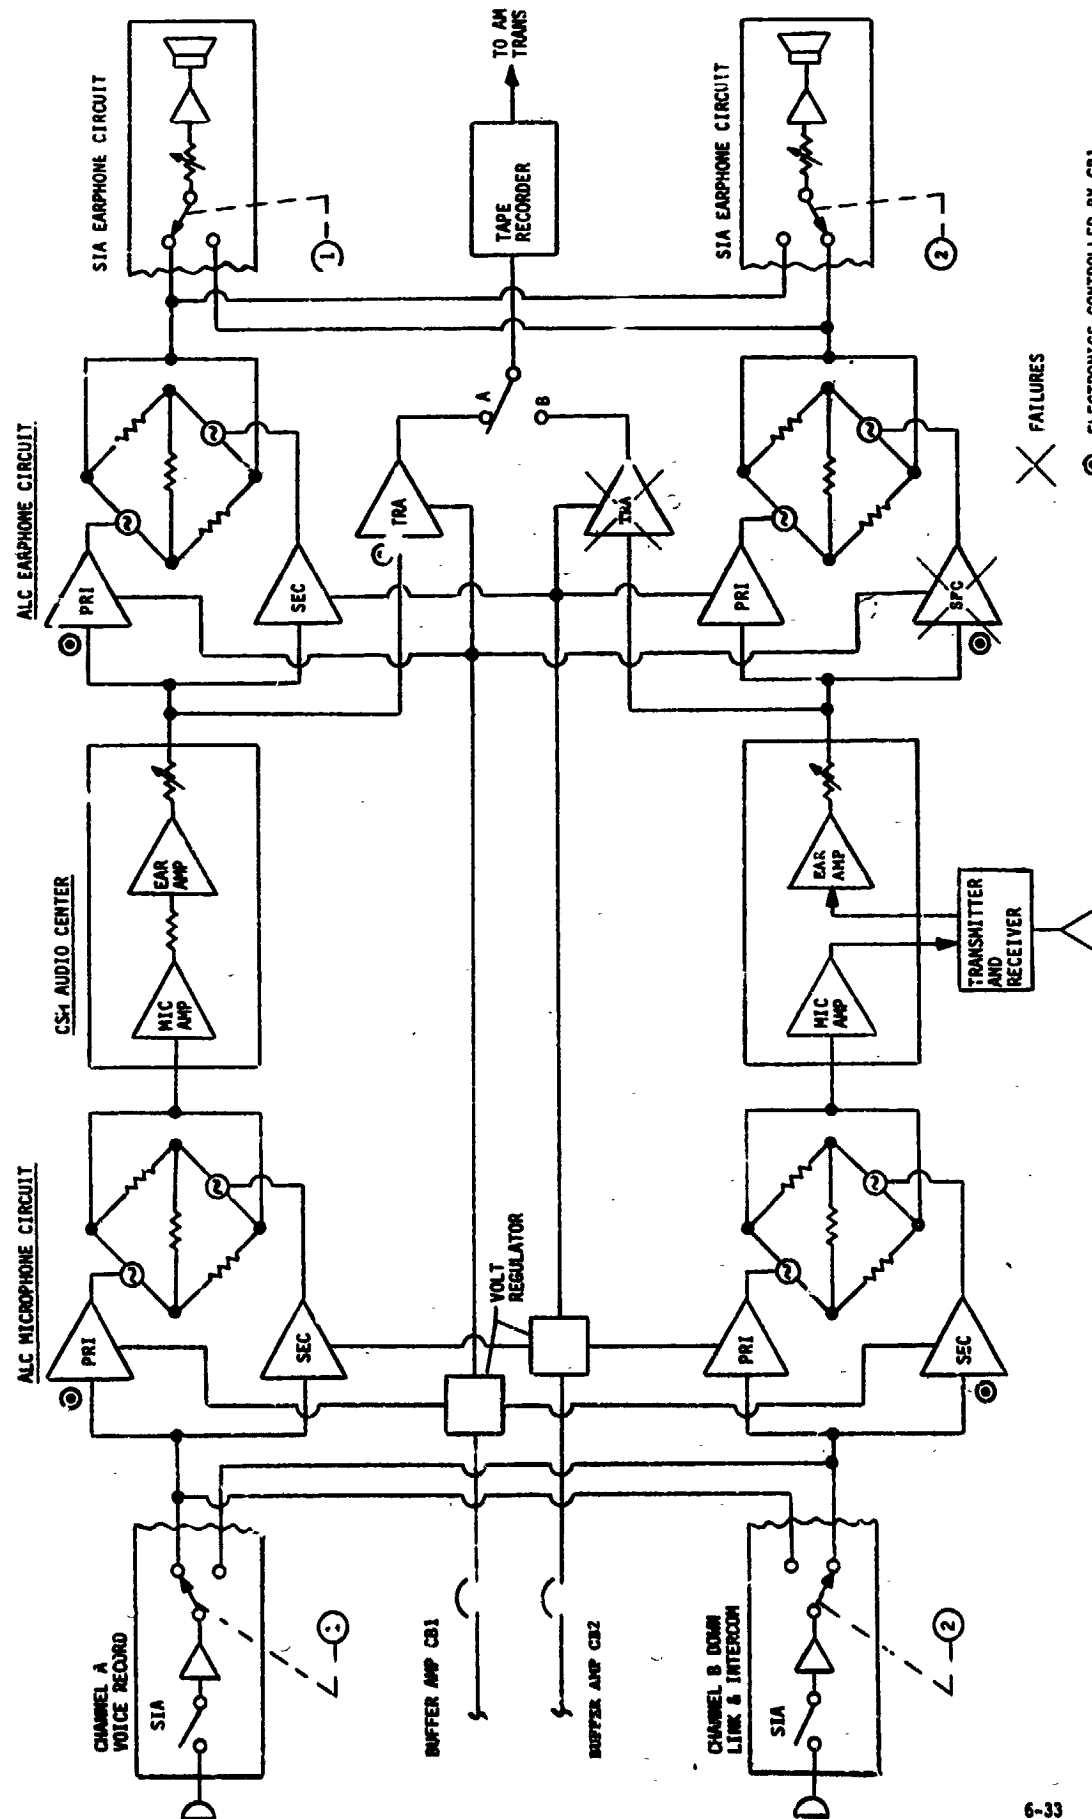
FIGURE 6-13 AUDIO FLOW DIAGRAM - ALC

(b) During the second manned phase, the first audio equipment problem occurred on DOY 213 when playback of the voice received at the STDN was garbled. Checks made on Channel B identified the failure to be the tape recorder amplifier in Channel B of the ALC (see Figure 6-13). This failure in no way degraded the normal intercom loop. Since Channels A and B were identical, the work-around was to reverse the channel configuration whereby Channel B was used for

intercom and downlink while Channel A was used for voice recording (see Anomaly Report No. 213 For additional details).

This problem was similar to a discrepancy that occurred for a short period on DOY 265. However, in that case the problem occurred in the CSM after undocking and was attributed to the CSM. The ground implemented a crew diagnostic procedure whereby the backup audio center was switched into the Channel B circuit. The problem still existed and troubleshooting of the earphone amplifiers of the Channel B was initiated. By opening and closing the two buffer amplifier circuit breakers sequentially, the noise disappeared when circuit breaker no. 1 was opened (see Figure 6-13).

As noted in Figure 6-13, opening circuit breaker 1 also disabled the remaining operational tape recorder amplifier of Channel A. Therefore, when voice recording was required it was necessary to go to the AM control panel and close this switch during voice recording. This procedure was tolerated since there were only 16 days left in the mission before final deactivation.

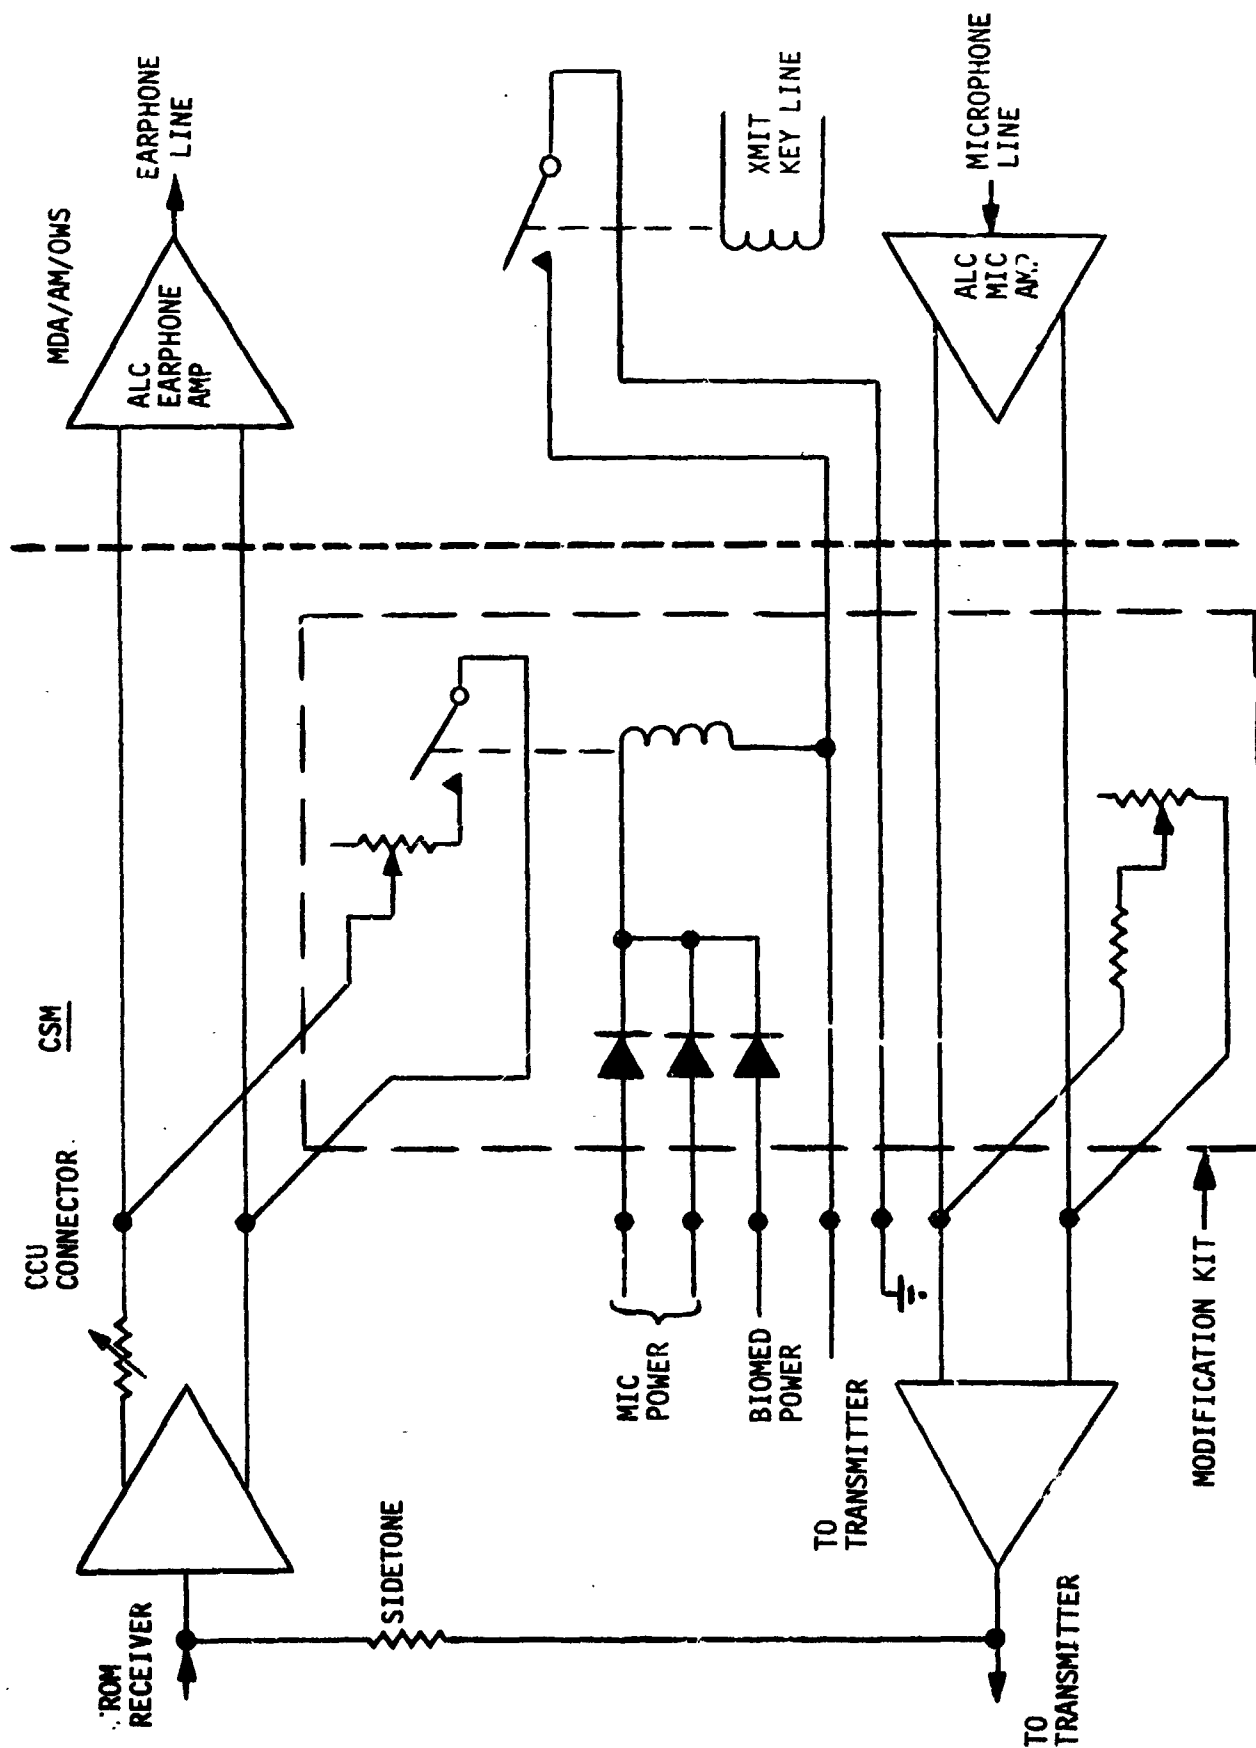
FIGURE 6-14 AUDIO ANTI-FEEDBACK ADAPTER

In evaluating a device to reduce feedback, three areas were investigated: (1) reduce the overall gain of the audio system; (2) provide better equalization in the sidetone level of the intercom and PTT mode; and (3) any modification would have to be easily installed inside the Skylab. The final modification as flown and installed during the third manned phase of the mission is shown in Figure 6-14. This kit modified the system as follows:

CSM audio center was reduced by a factor of 11 dB by the insertion of an additional load.

(2) Audio Antifeedback Modification Kit. In order to reduce the feedback prevalent during the first and second manned phases, an antifeedback network assembly was installed during the third manned phase. A block diagram is shown in Figure 6-14. The microphone signal to the CSM was desensitized by padding the line for an 11 dB signal attenuation. As noted on the AGC curve of Figure 6-16, attenuating the voice input by 11 dB shifted the normal operating range towards the knee of the curve. Decreasing the input to the CSM audio center also shifted the unvoiced microphone input away from the effects of the AGC action.

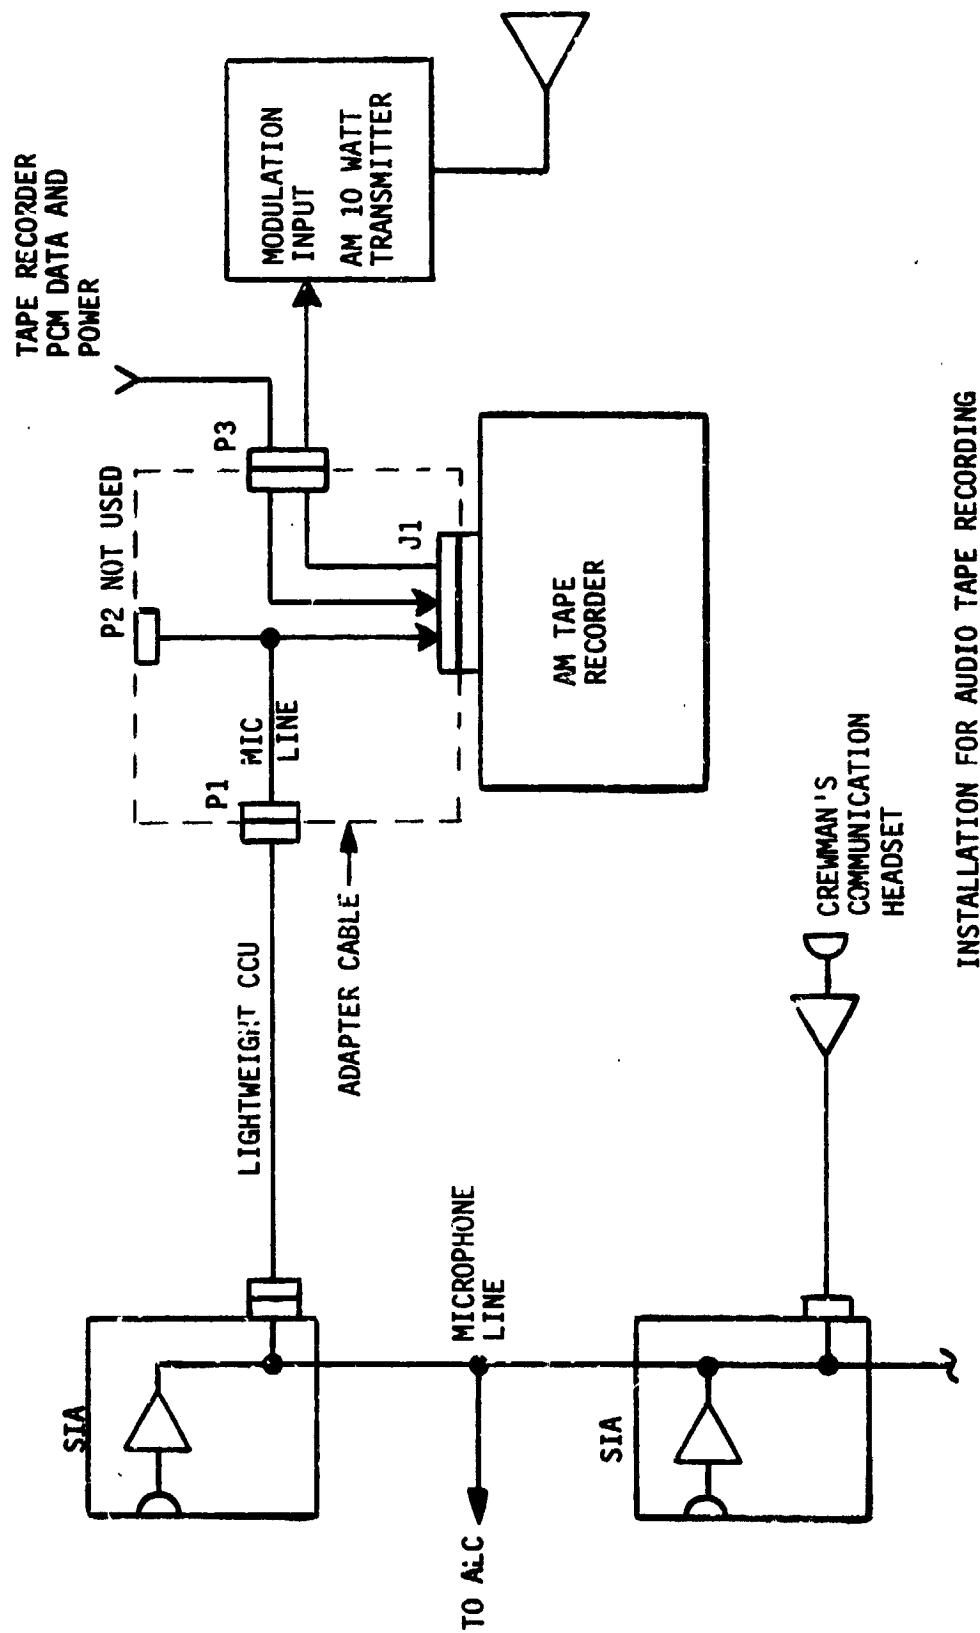
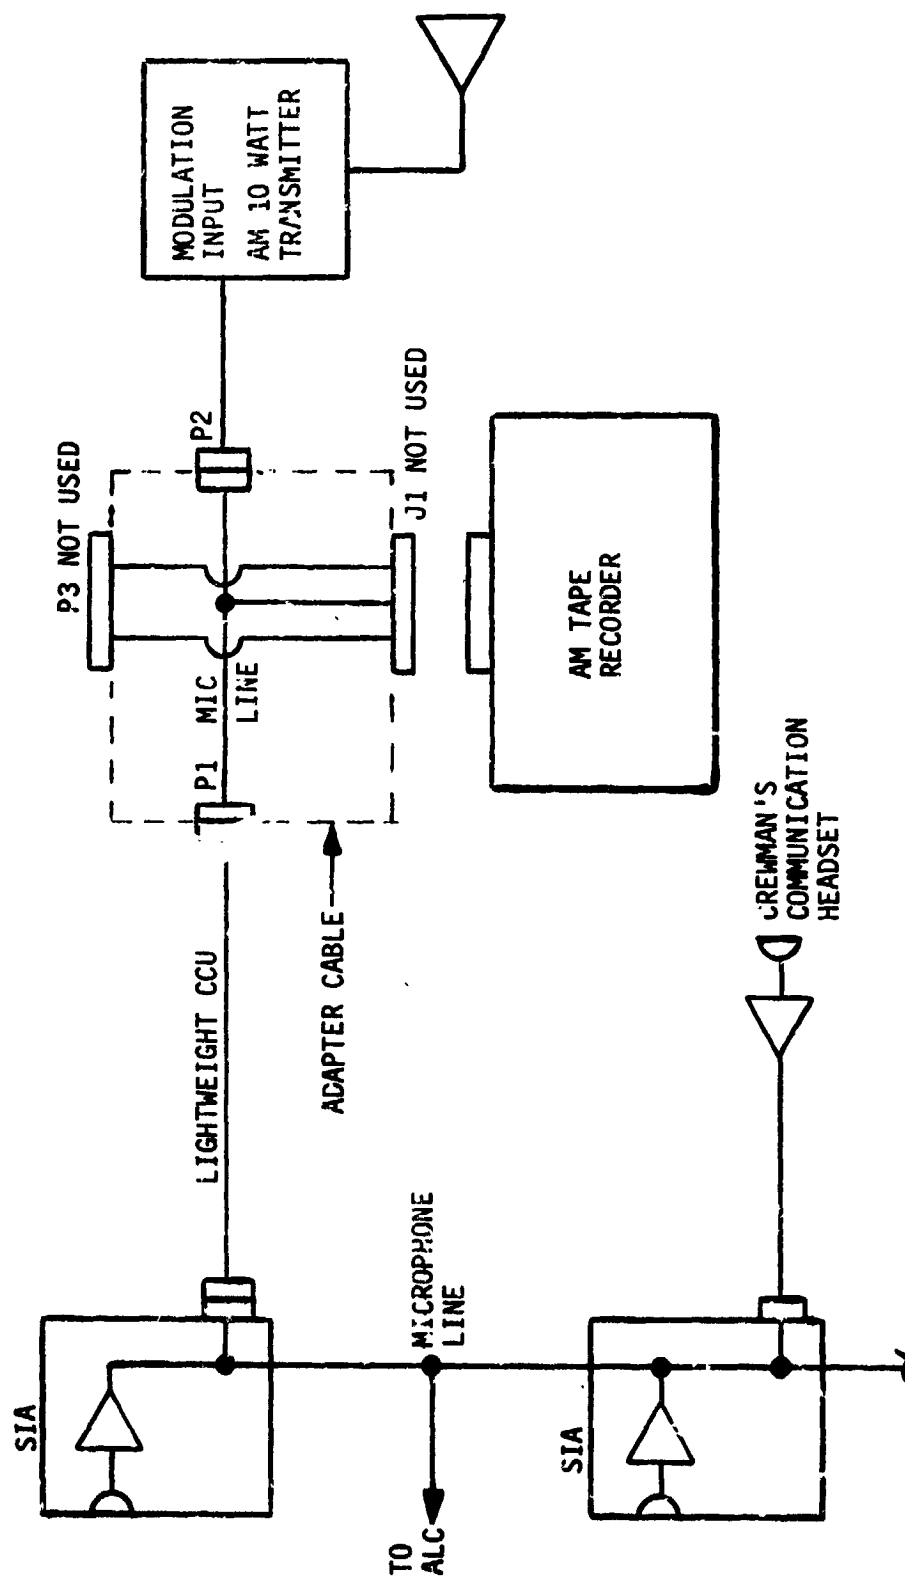
FIGURE 6-17a EMERGENCY TAPE RECORDER VOICE CABLE ASSEMBLY

- (1) One of two tape recorder amplifiers was operating.
- (2) One of two earphone amplifiers in the Channel B of the ALC was operating.
- (3) All SIA stations were active.
- (4) An antifeedback network assembly was installed on the air-to-ground channel.
- (5) A recorder/ALC bypass cable was designed and stowed on Skylab for backup capability.

With the loss of a tape recorder amplifier in Channel B of the ALC, the STU-STDN facility investigated the possibility of providing an alternate means of recording voice if the remaining voice record circuit of Channel A should fail during the third manned phase. By analyzing the available electrical connections inside the Skylab, a contingency emergency/voice tape recorder adapter cable was developed as a backup to a Channel A failure and stowed in the CSM for SL-4.
